Inspection Report

1111 Nowhere Dr

1 Report Information

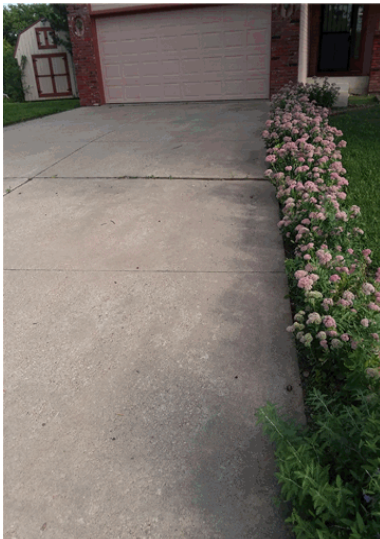
2) Driveway Conditions

Appears to be in serviceable condition. There are some minor cracks and sinking that is normal for the age and use of the concrete.

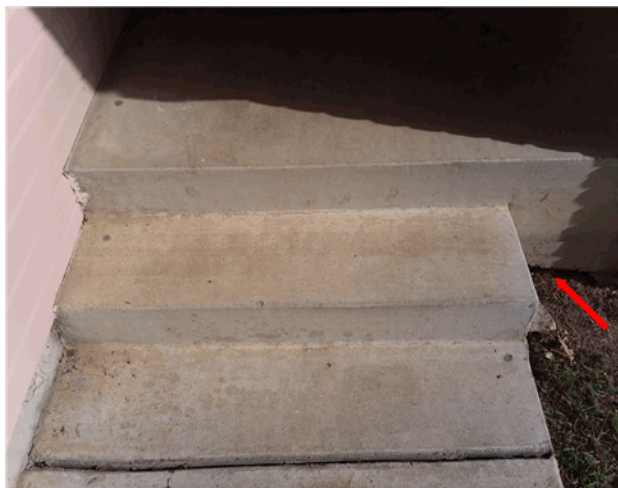
3) Sidewalk Conditions

The earth appears to have washed out from under the front sidewalk and porch, undermining may lead to cracks and sinking in the sidewalk and porch. Repair is suggested.

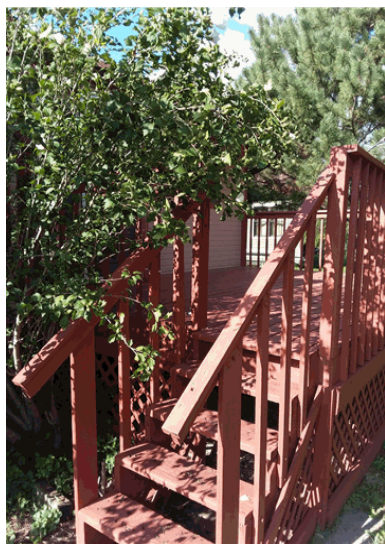
5) Back Entrance
Conditions

There is a bush overhanging the stairs to the back porch

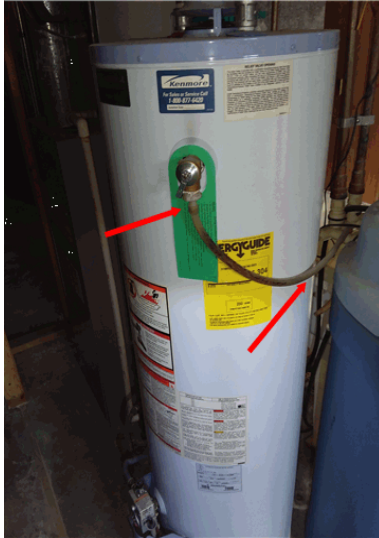
27) Water Heater Conditions

The TPR valve drain pipe should terminate no more than 6 inches above the floor. Currently the drain pipe attached to the TPR valve is a flexible piece of hose that does not drain to the floor. **This is considered a safety issue and should be repaired as soon as possible.**

Tpr valve will not drain properly

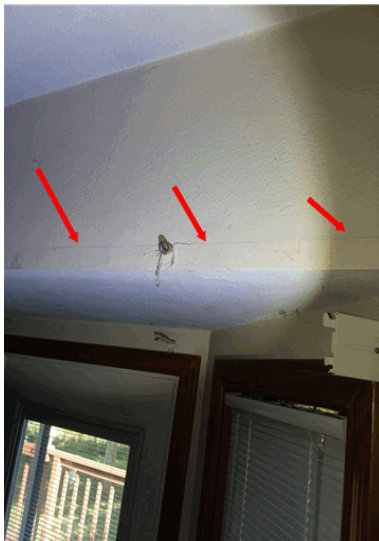
28) Wall Conditions

There are a few small cracks in some places in the walls near coroners

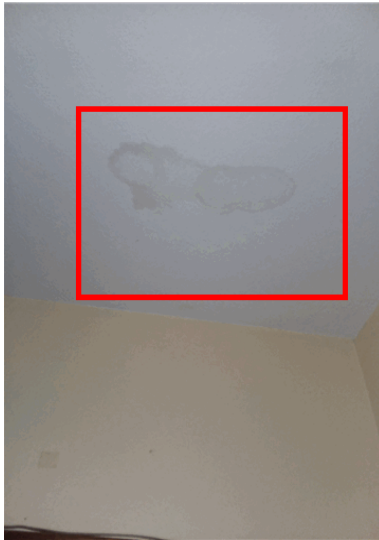
29) Ceiling Conditions

There is a stain on the ceiling in the dining room. This could be caused by a leak from the attic, however no evidence of a leak was observed during the attic inspection.

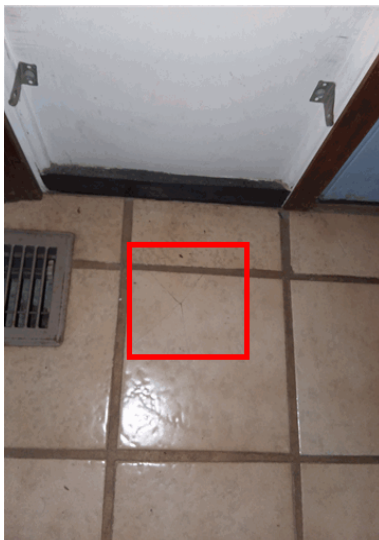
30) Floor Conditions

The tile near the front entrance are cracked and numerous places

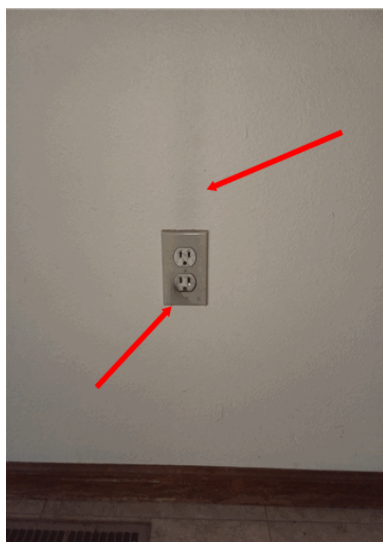
44) Electrical
Conditions

There are smoke stains on the electrical outlet in the dining room. This is a safety concern, further inspection by an electrician is recommended.

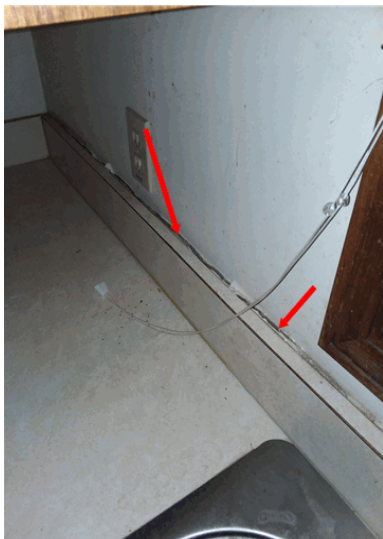
47) Counter Conditions

The kitchen countertop appears to be pulling away from the wall

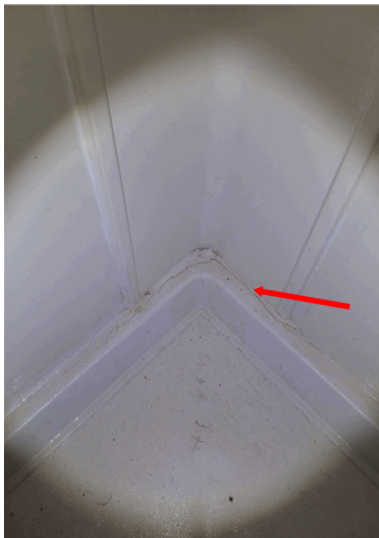
65) Shower - Tub
Conditions

Low pressure noted in all bathroom sinks and showers. The caulking between the base and shower wall in the shower of the basement bathroom appears to be cracking which may allow water to drain into the spaces behind the shower wall. Further inspection by a plumber is recommended.

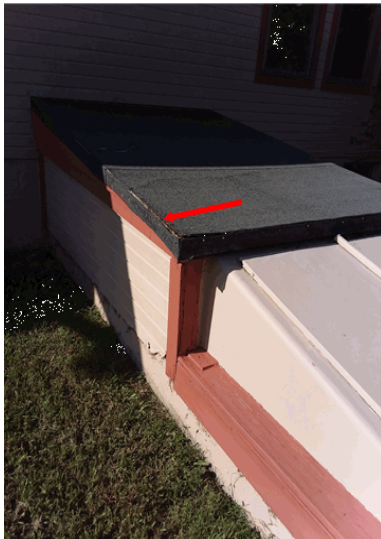
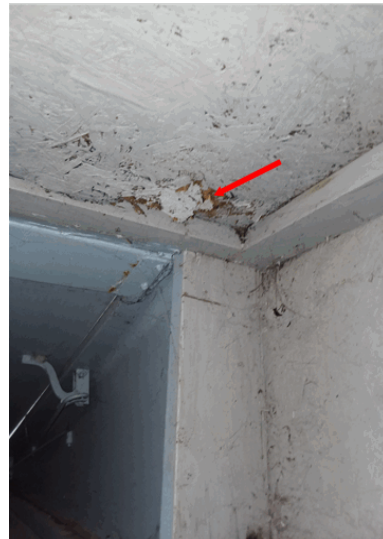
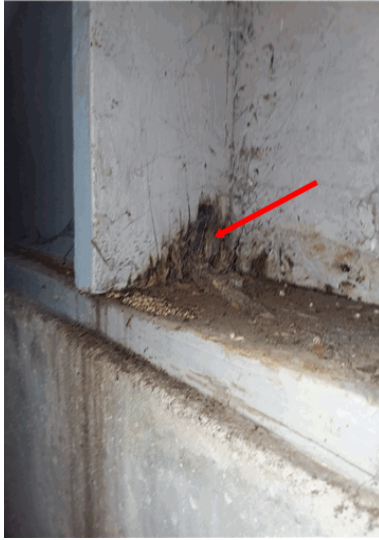
73) Basement Door
Conditions

The basement door is weather protected by a storm shelter entrance. The roofing and interior framing is rotting in places. Further inspection and repair is recommended.

storm shelter entrance exterior

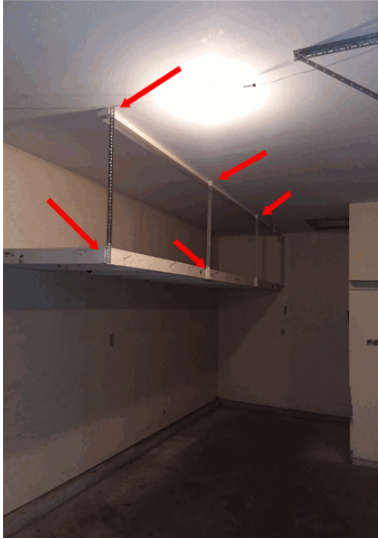
86) Garage Condition

There are storage shelves in the garage that appear to have been installed professionally. These shelves may not be secure. Further inspection by a construction professional would be required to determine the integrity of the construction.
